Description, application, and handling of the FLUXA[®]-test block (Article no. 9803.001)

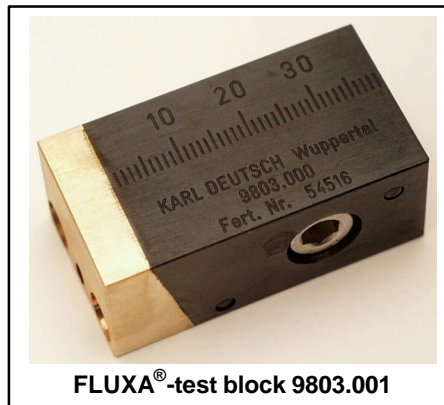
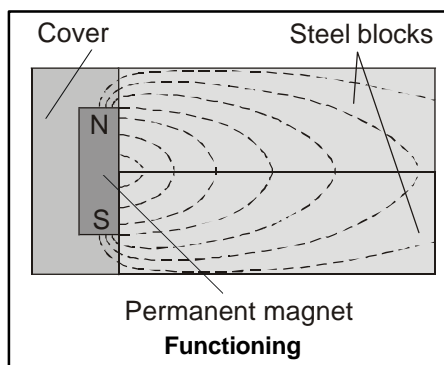
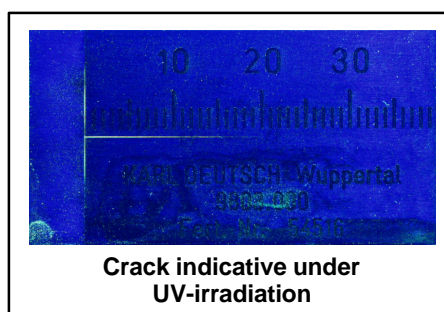
Description: The FLUXA[®]-test block consists of two precisely ground steel blocks which form an artificial crack at their contact areas. On one front side, a permanent magnet is arranged under a brass cover. This magnet causes a magnetic stray flux across the artificial crack, which decreases more and more with increasing distance from the magnet. Thus, a deterioration of indication sensitivity can be determined by a reduction of the indication length.

Application: The FLUXA[®]-test block is, for a few seconds, immersed into or carefully sprayed with the well-mixed inspection medium. Redundant inspection medium should be dropped off. After this, the artificial crack is to be inspected under UV light (inspection conditions according to EN ISO 3059 should be ensured) and its length to be read from the engraved mm scale and recorded.

- By a mechanical impact (e.g. falling down), the precisely ground areas can be shifted against each other. Also in this case, a continuous or interrupted or a re-appearing indication at the right side may be seen, in most cases together with a reduction of the indication sensitivity. In case of a mechanical damage, a repair, unfortunately, will not be possible. We therefore recommend a careful handling of the test blocks. Please avoid any engraving or marking punch. Furthermore, the FLUXA[®]-test blocks should not be clamped in a vice nor demounted.
